PRELIMINARY VISUAL IMPACT ANALYSIS

NOVEMBER 2014

**AMBLER MINING DISTRICT INDUSTRIAL ACCESS ROAD
PRELIMINARY VISUAL IMPACT ANALYSIS**

November 2014

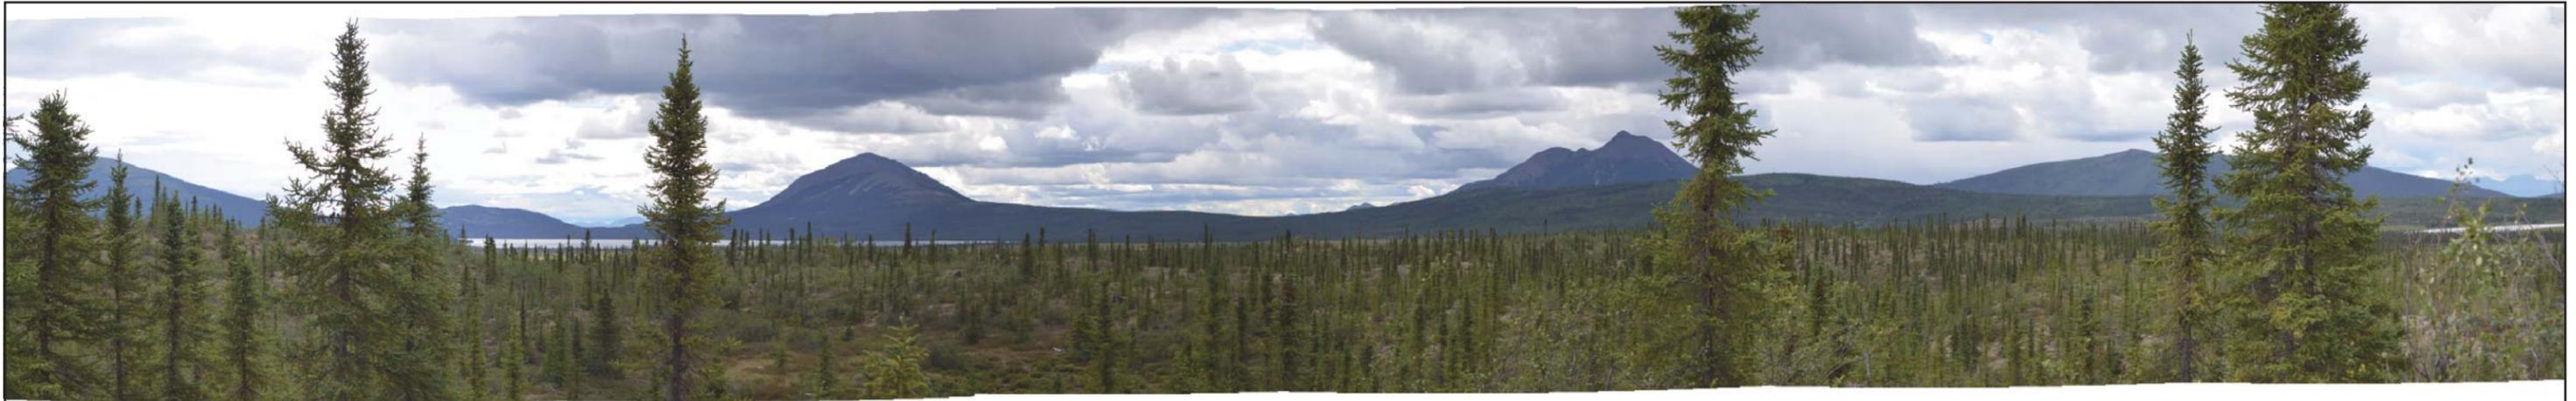
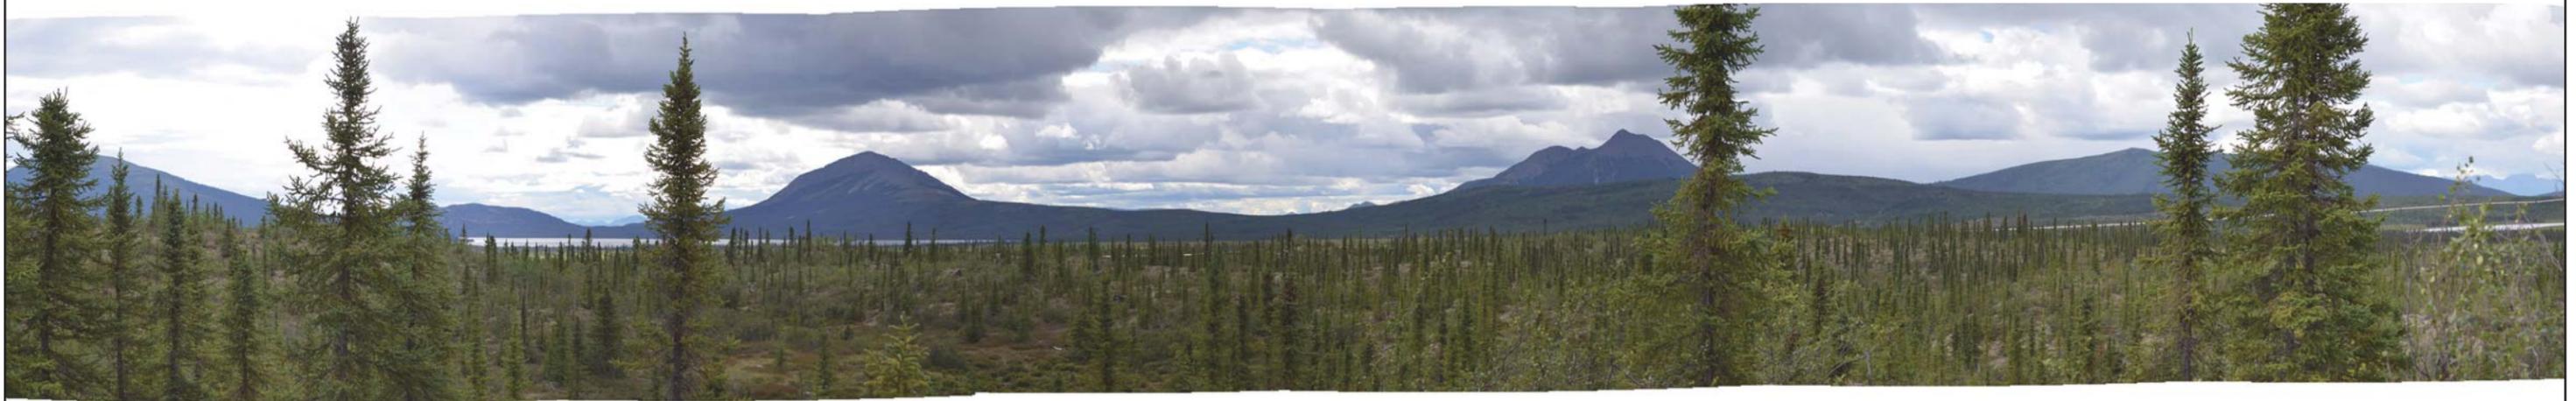
GAAR Visual Impact Analysis KOP 1 - ROW West Low	
	Ambler Mining District Industrial Access Road	
	November 07, 2014	Figure 4

This location is near the western boundary of the Preserve. The observation point is looking south in an open spruce forest with low shrubs and has a distant view of Nutuvukti Lake two miles away. This is a wilderness location with no man made elements visible and no trail access. The Reed River is 2.1 miles to the west. Figure 4 shows the existing view from KOP 1.

AMDIAR traverses from the right side of the view down slope and across a moraine near a small lake. The road then disappears from view behind a rise in the foreground topography. As the road reappears in the center right of the view it crosses through lower ground and is largely screened by vegetation before again disappearing behind a slope on the viewer's left. The road footprint in this area averages 80' wide with fill slopes 8' high. Figure 4 shows the view from KOP 1 with the simulated road.

KOP 1 - ROW West Low Existing - Looking South / Southwest (North Route)

KOP 1 - ROW West Low After Construction - Looking South / Southwest (North Route)

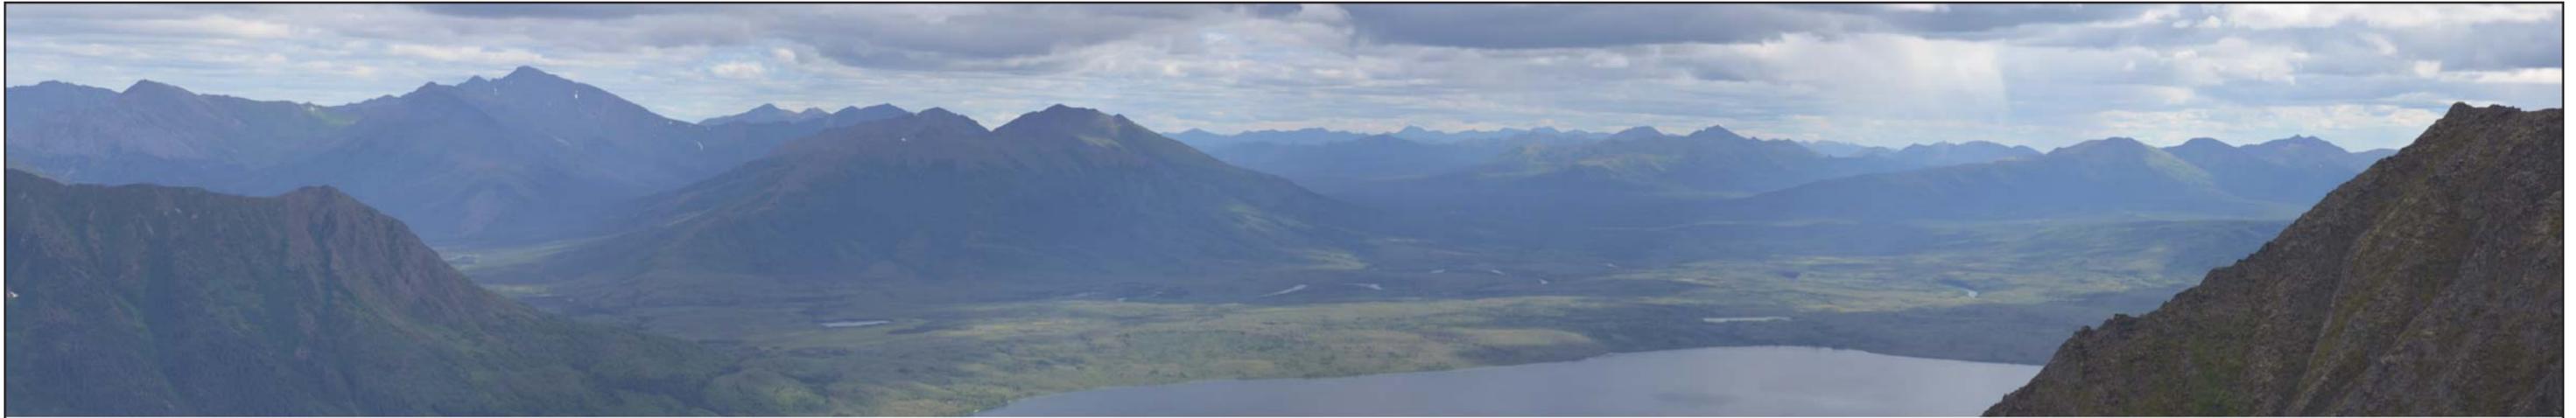
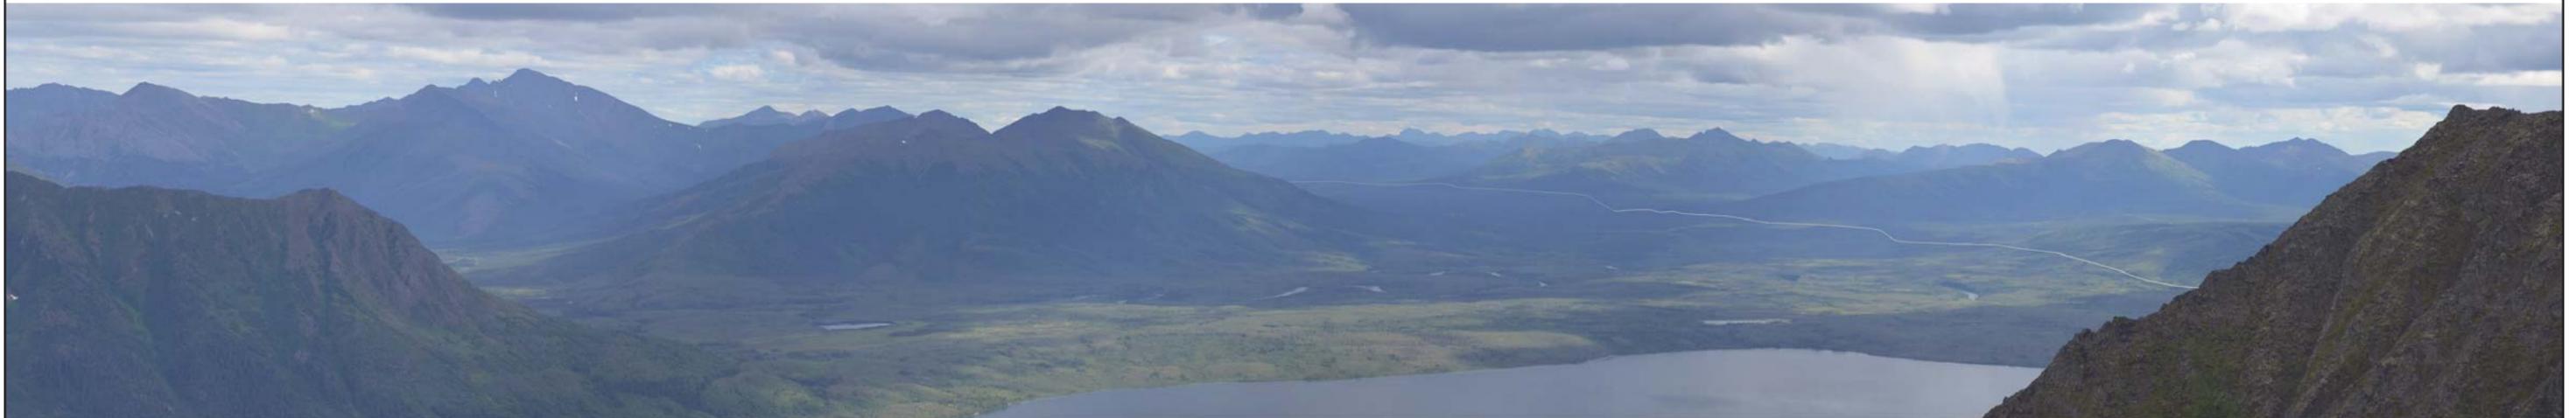
GAAR Visual Impact Analysis KOP 2 - Walker Lake High West	
	Ambler Mining District Industrial Access Road	
	November 07, 2014	Figure 5

High on a mountain ridge above Walker Lake, this observation point has a clear view from northwest to southeast. The location is difficult to access as it requires an off-trail climb up steep mountain slopes. At least three cabin structures are visible around Walker Lake. Figure 5 shows the existing view from KOP 2 toward the east and southeast. Expansive views continue around to the northwest capturing the Arrigetch Peaks, Walker Lake and Mount Igikpak. These additional images were not included as the road would not be visible in this portion of the view and also the resulting panorama would have been too large to fit without significantly shrinking the image for reproduction in this report.

KOP 2 - Walker Lake High West Existing - Looking East / Southeast (North Route)

KOP 2 - Walker Lake High West After Construction - Looking East / Southeast (North Route)

From KOP 2 the AMDIAR northern route lays approximately 7.25 miles at its closest visible point where it comes into view beyond a mountain buttness at viewer's right at a southeast orientation. The road travels away from KOP 2 as it makes its way to the east, from right to left, along the northern edge of the Helpmejack Hills. The road extends beyond 15 miles from the KOP before a mountain blocks it from view. It is difficult to determine at what point the road moving away from the KOP would no longer be visible to the naked eye. No attempt was made to incorporate the effect of vegetative screening for this distant view of the road, though photos taken from KOP 4 indicate the presence, of dense, mature spruce forest. This suggests a high probability of vegetation providing a substantial amount of screening for large segments of the road. Figure 5 shows the view from KOP 2 with the simulated road.

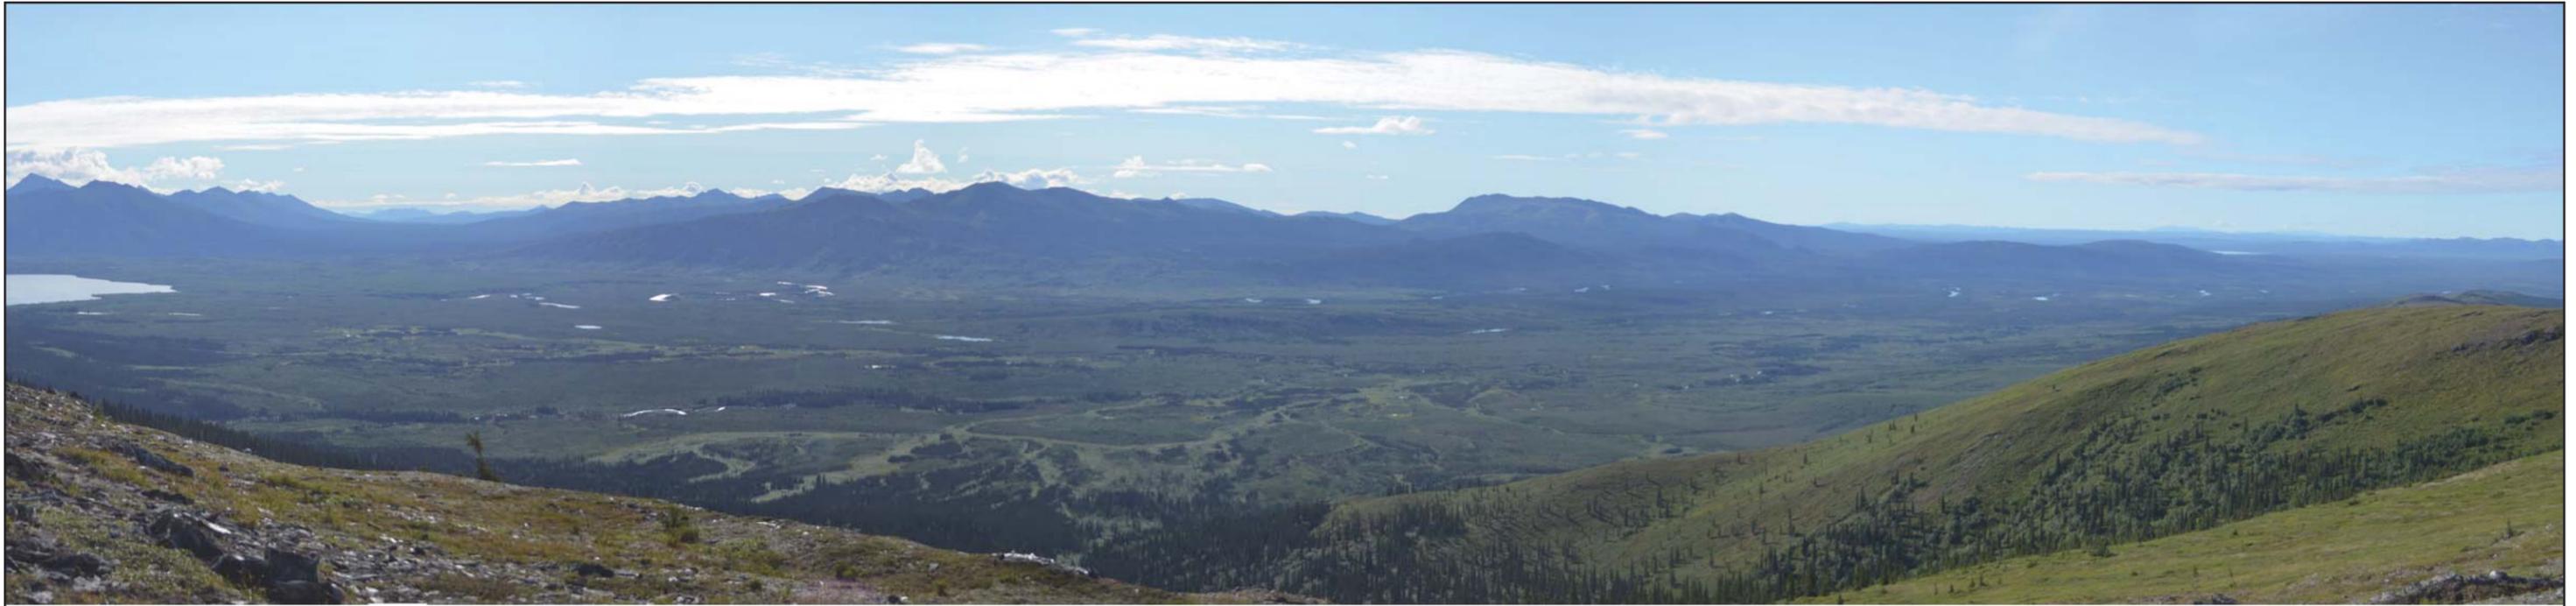
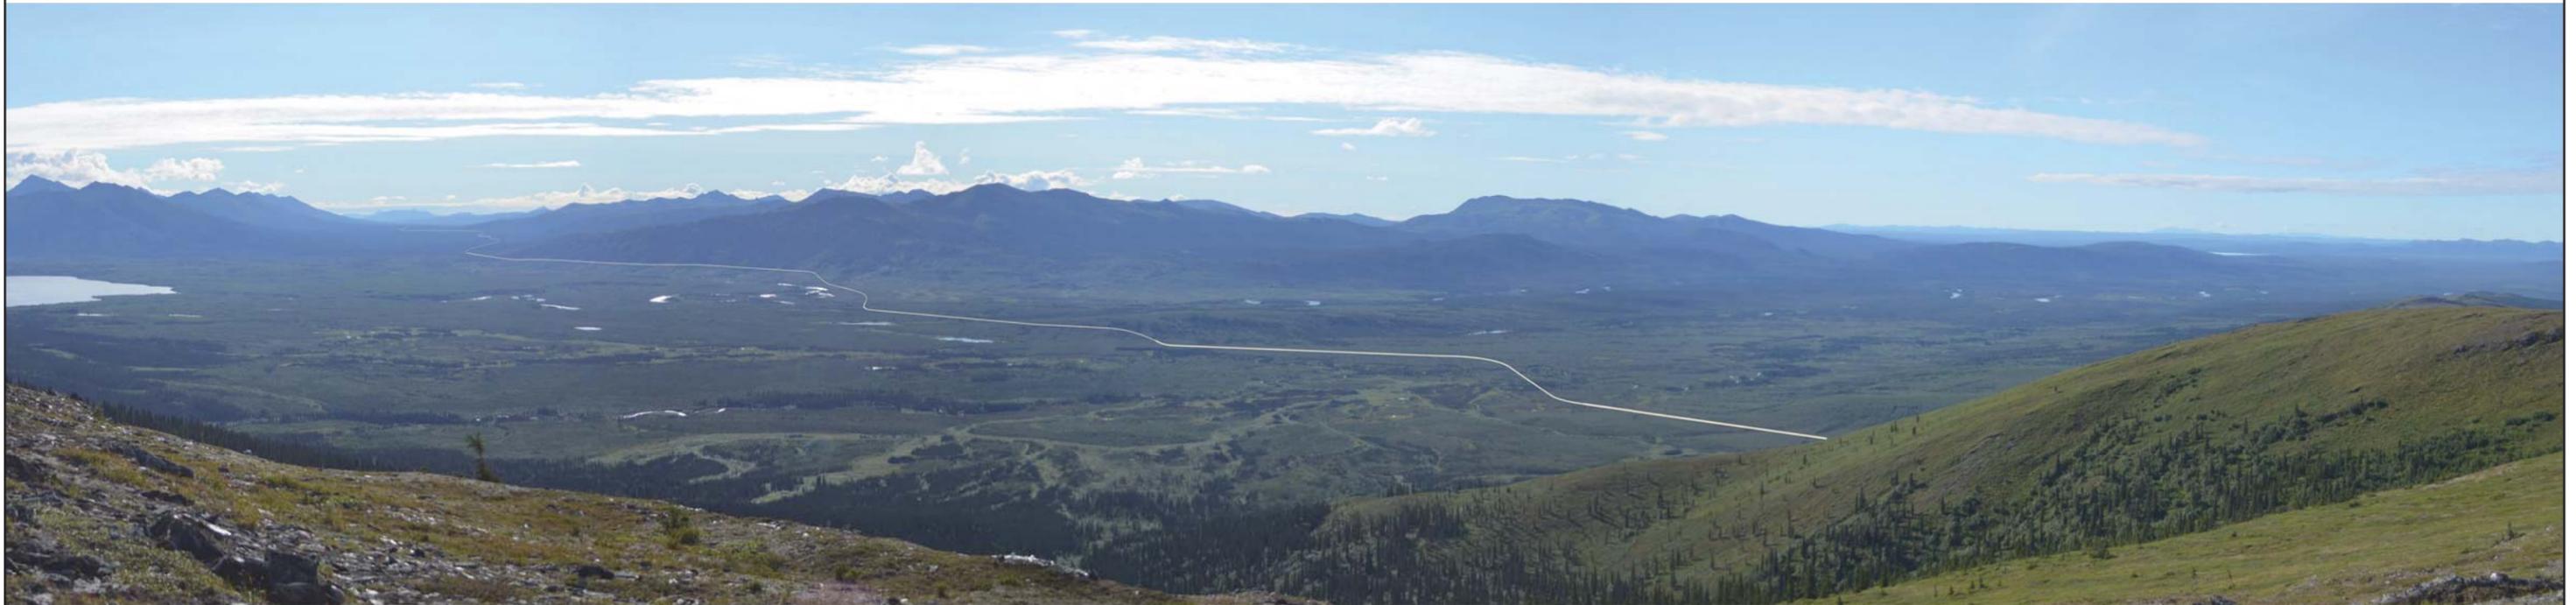
GAAR Visual Impact Analysis KOP 3 - ROW West High	
	Ambler Mining District Industrial Access Road	
	November 07, 2014	Figure 6

This observation point is located on a high hilltop looking southeast over the Kobuk River valley. The southern tip of Walker Lake is visible 5 miles to the west at viewer's left and the Kobuk River is 4.75 miles at its nearest point. There are no trails or roads to KOP 3 and no manmade structures are visible. Figure 6 shows the existing view from KOP 3 to the east and south.

The visual simulation for KOP 3 demonstrates that the AMDIAR northern route would be more visible than at the previous two KOPs. KOP 3 has an elevated view as does KOP 2, but it is much closer to the road being 2.2 miles from the nearest visible point. From this near point the road moves away to the east (from right to left) passing through lowlands and crossing the Kobuk River. The lowlands are primarily vegetated with shrubs that would likely provide only minimal screening of the road. The road does not reach vegetation large enough to aid screening of the view until it reaches the base of the Helpmejack Hills approximately 6.75 miles from KOP 3. Figure 6 shows the view from KOP 3 with the simulated road.

KOP 3 - ROW West High Existing - Looking Southeast (North Route)

KOP 3 - ROW West High After Construction- Looking Southeast (North Route)

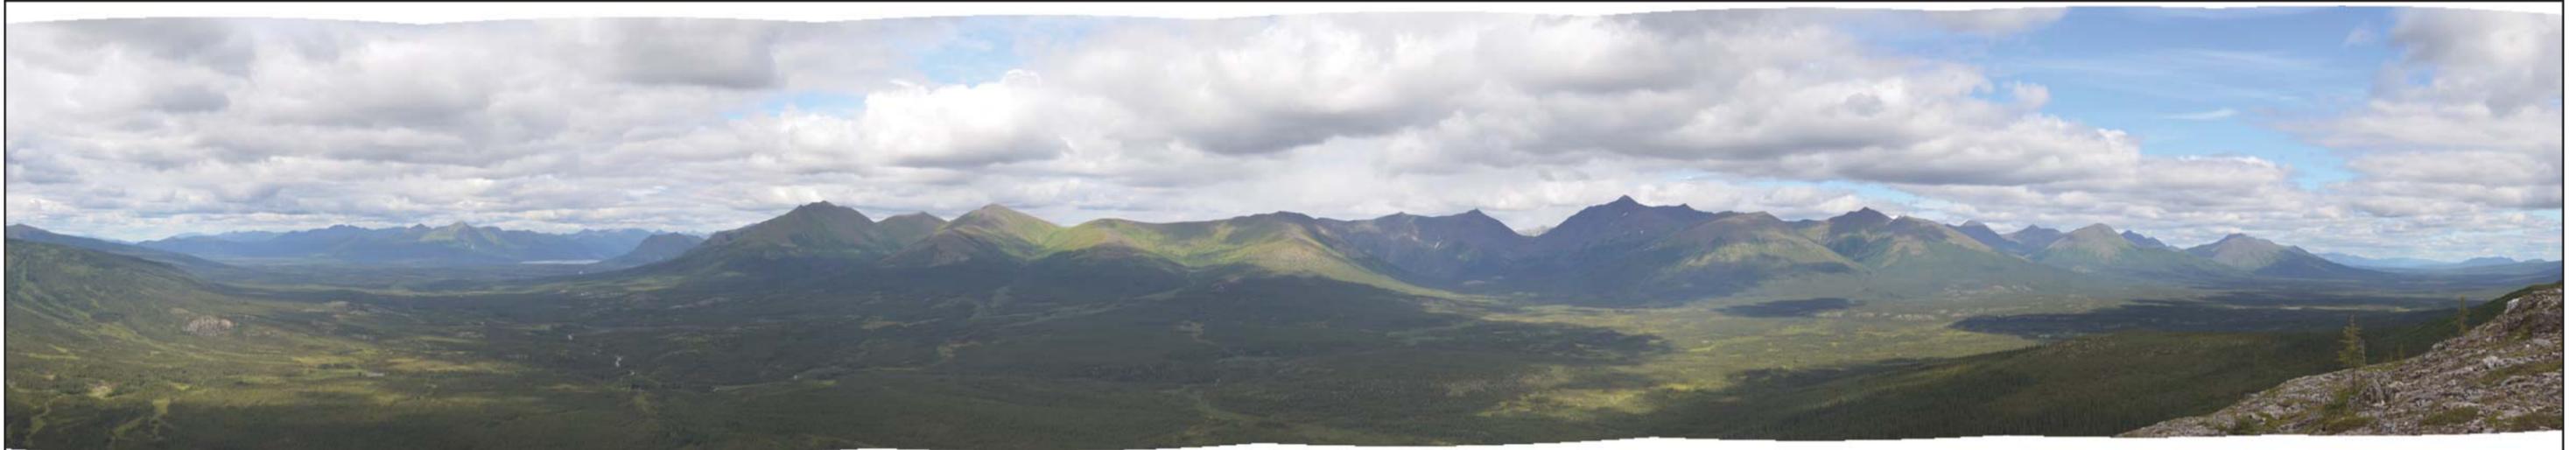
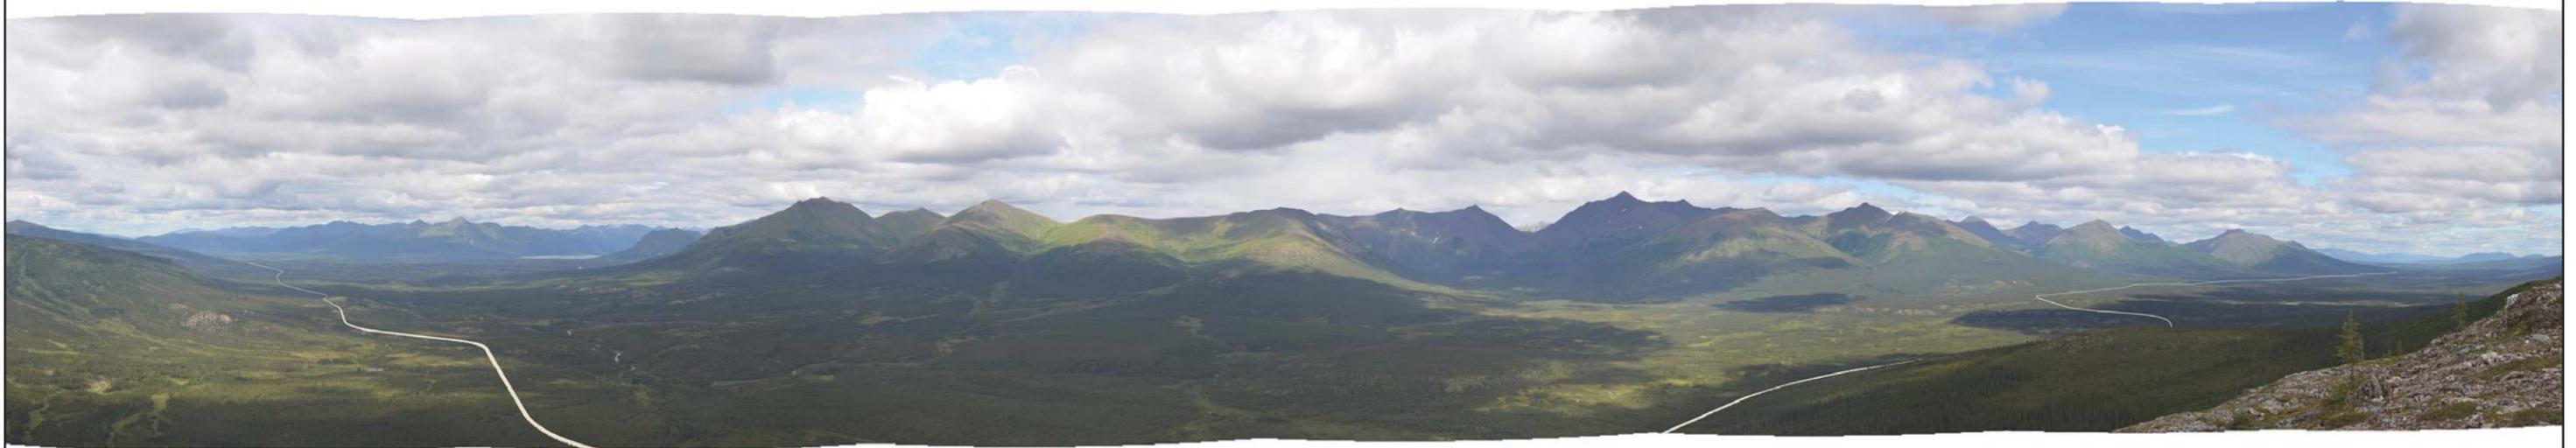
GAAR Visual Impact Analysis KOP 4 - ROW East Boundary	
	Ambler Mining District Industrial Access Road	
	November 07, 2014	Figure 7

Another elevated observation point looking north with expansive views from east to west, KOP 4 is located 0.9 miles inside the eastern boundary of the Preserve and 1.4 miles south of the Kichaiakaka Creek, which forms the boundary between the park (wilderness) and preserve. The Kobuk River is 6 miles to the west, making KOP 4 further from a major water course than any of the other KOPs. Figure 7 shows the existing view from KOP 4.

The visual simulation indicates that the road would likely be visible alongside Kichaiakaka Creek on the left side of the scene. This section is populated by sections of sparse and dense forests that reside on the north side of the Helpmejack Hills. Despite the presence of dense, mature spruce forest, vegetative screening is likely to be minimal because the road is oriented toward the KOP, meaning that a viewer is looking down the length of the alignment in a fairly direct manner. As the road passes in front of the KOP at the center of the scene, vegetation and topography block any view to the road. The road emerges right of center as line of sight is reestablished. This next segment of road would likely be partially screened by tall spruce trees before disappearing behind another terrain feature. Next, the road crosses from the south side of the valley to the north and again becomes visible while traversing a slope that faces the KOP. Once on the north side of the valley the road turns east once again and travels through dense spruce forest. At this point the road is beyond 3 miles from the KOP and the level of vegetative screening is difficult to determine and accurately portray. It is likely that this portion of the road would be substantially or completely screened from view. Figure 7 shows the view from KOP 4 with the simulated road.

KOP 4 - ROW East Boundary Existing - Looking North (North Route)

KOP 4 - ROW East Boundary After Construction - Looking North (North Route)

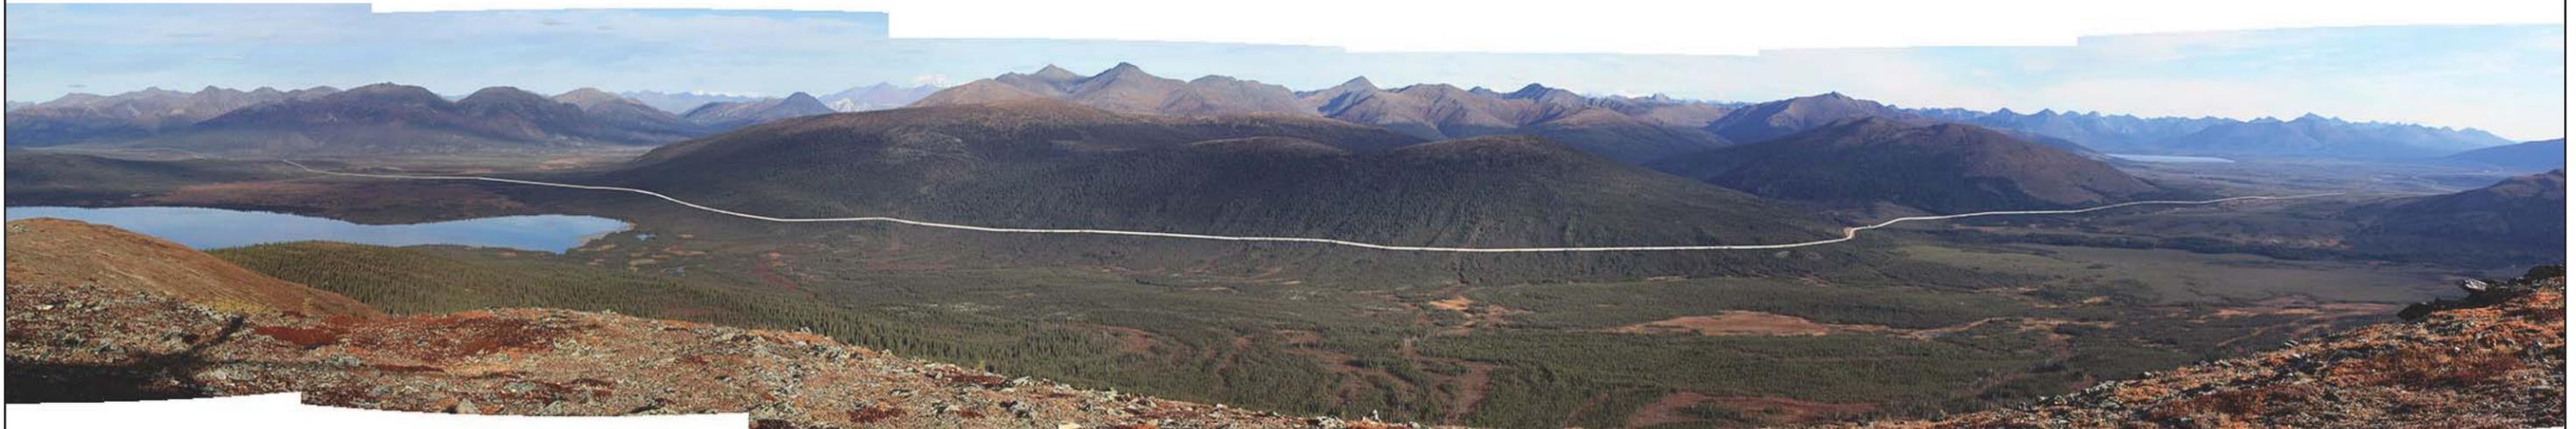
GAAR Visual Impact Analysis KOP 5 - Nutuvukti Summit	
	Ambler Mining District Industrial Access Road	
	November 07, 2014	Figure 8

There are 360 degree views of the surrounding landscape from Nutuvukti Summit, but KOP 5 is oriented to the view north. Only 1,740' below, Nutuvukti Lake is prominent and provides visitor access via float plane. A cairn had been constructed near this observation point, which reinforced the thought that this may be a site used by visitors and supported its selection as a KOP. There is also a cabin on the north shore of Nutuvukti Lake but it is difficult to see and doesn't impact the natural view. This is likely the most accessible of all the elevated observation points visited. Walker Lake can be glimpsed 9.5 miles to the east. Figure 8 shows the existing view from KOP 5.

The AMDIAR is likely to be visible for a substantial distance from this viewpoint. The road traverses low on a broad south facing slope, elevating it above the valley floor. The road is primarily in a fill along the entire length of the traverse and has an average fill slope height of 18 feet. This embankment would create a larger visual impact than if constructed on flat terrain. Sections of large spruce forest along the hillside would mitigate some of the visual disturbance, but from the elevated KOP the line of sight would not be screened as much as at a lower angle view from the valley floor.

KOP 5 - Nutuvukti Summit Existing - Looking North (North Route)

KOP 5 - Nutuvukti Summit After Construction - Looking North (North Route)

Re-vegetation of fill slopes with native seed, trees and/or shrubs on topsoil could be used as a mitigation technique to reduce the contrast between the gravel road and the existing forest. Additionally, realigning the road from where it contours along the side of hill in an extended traverse to the toe of the slope and closer to the valley floor would reduce the prominence of the road. Figure 8 shows the view from KOP 5 with the simulated road.

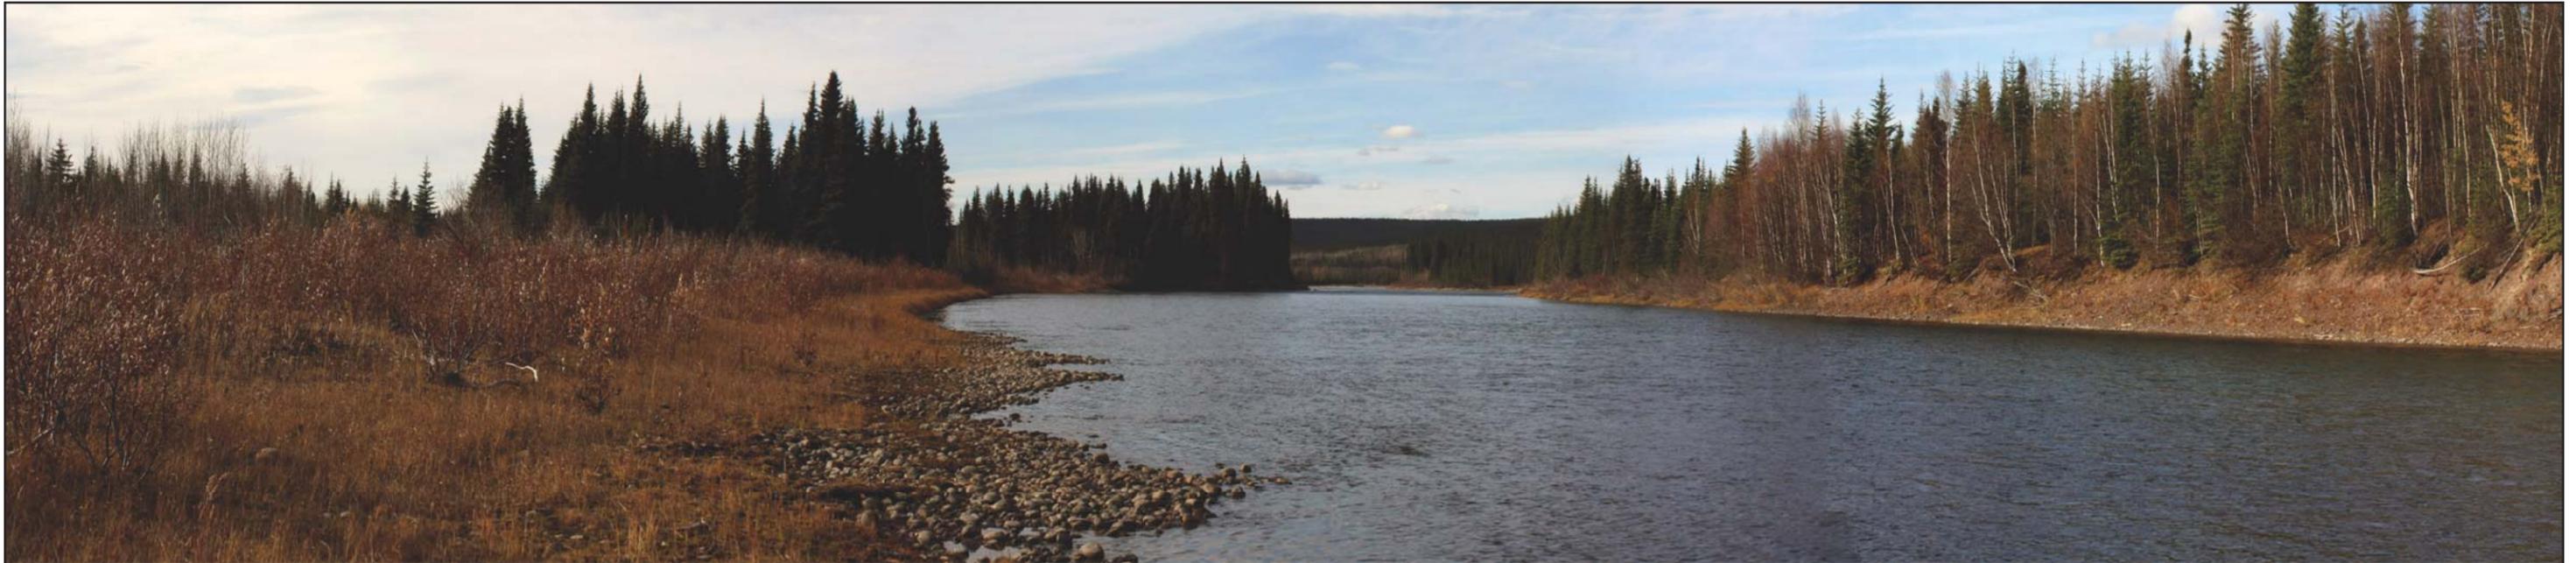
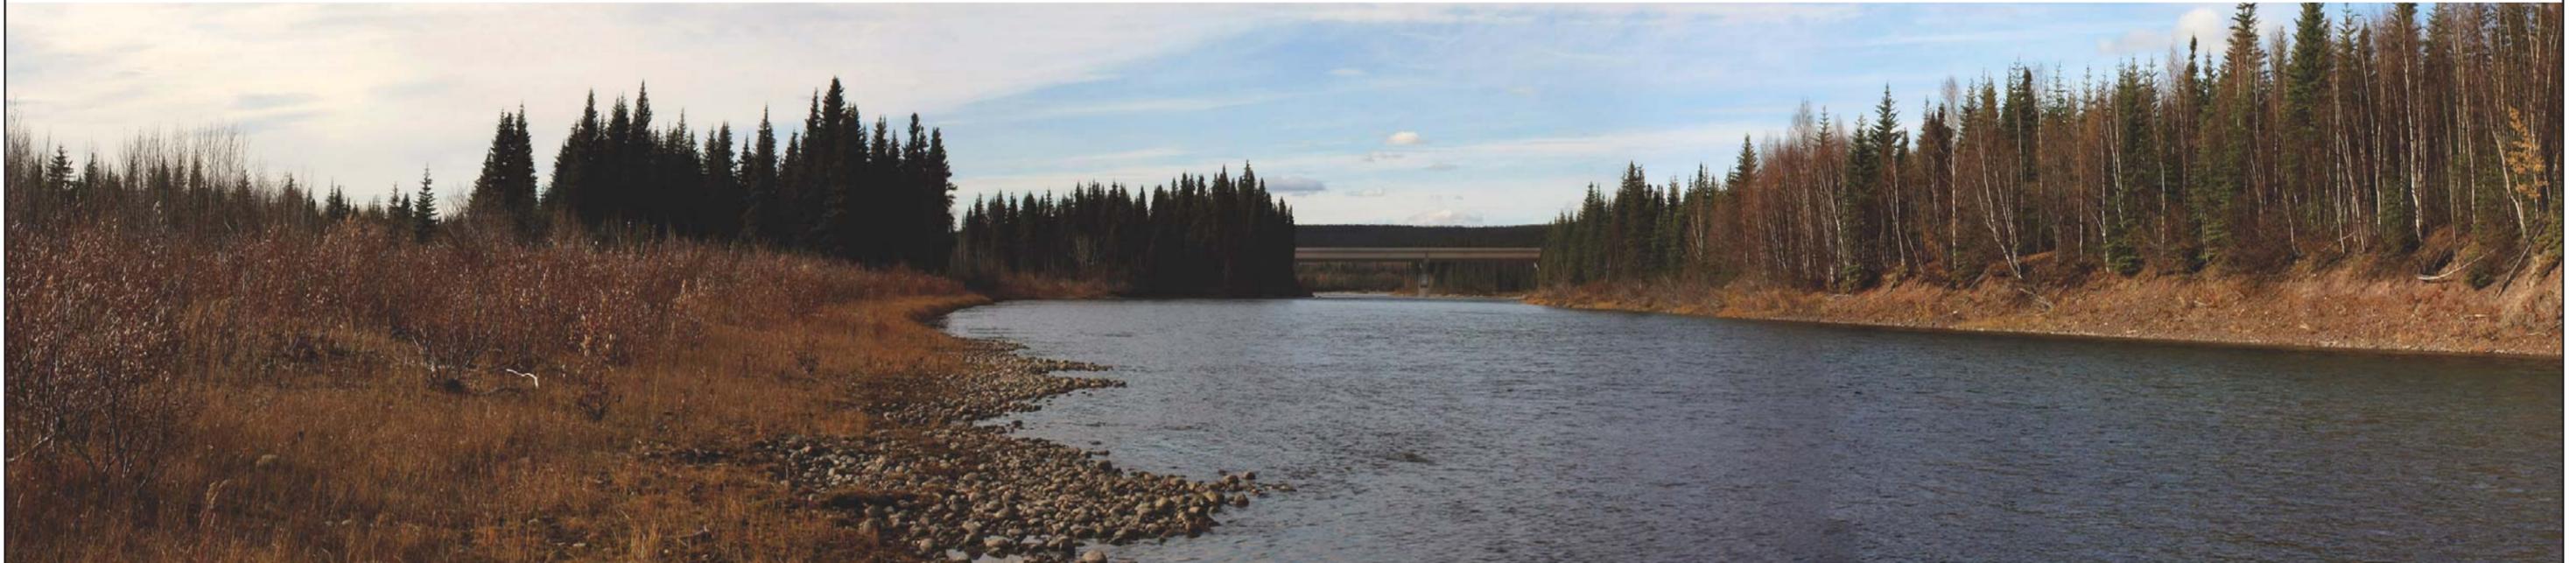
GAAR Visual Impact Analysis KOP 6 - Reed River 1	
	Ambler Mining District Industrial Access Road	
	November 07, 2014	Figure 9

Recreational users float the Reed River within GAAR, but the Reed River does not get as much recreational use as the Kobuk. KOP 6 can be expected to have visitors travel past it at a minimum, and has the potential to be used as a rest spot or campsite. This observation point was originally selected for its proximity to a bridge crossing for the AMDIAR southern route and is oriented to the west. Figure 9 shows the existing view from KOP 6.

Traveling along the river, it would be impossible to not see the bridge crossing, but as demonstrated in the visual simulation, the road on either side of the bridge will not be perceived by users from the KOP. Large spruce trees on the southern side of the river, and a mature mixed forest on the north side are successful vegetative screens. Time of day and the season play a part in mitigating the visual impact of the bridge crossing. The simulation shows the bridge blending in with a dark background due to the angle of the sun, cloud cover and a backlit condition. A photograph of an existing bridge taken from a similar orientation was used in this simulation therefore; we believe that this simulation is an accurate portrayal for the conditions present at the time of the site visit. Bridge color and texture could be considered for mitigation of future designs. Figure 9 shows the view from KOP 6 with the simulated road.

KOP 6 - Reed River 1 Existing - Looking West (South Route)

KOP 6 - Reed River 1 After Construction - Looking West (South Route)

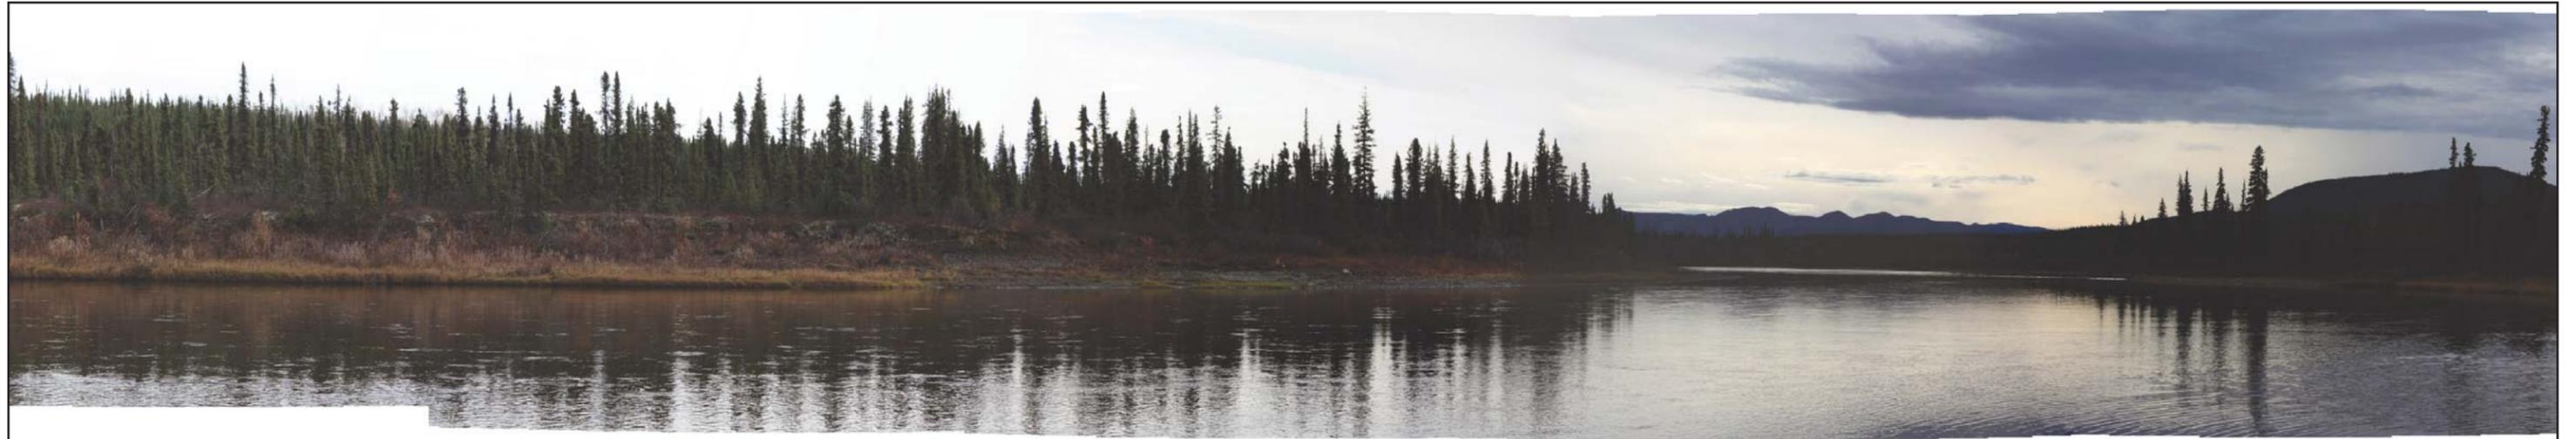
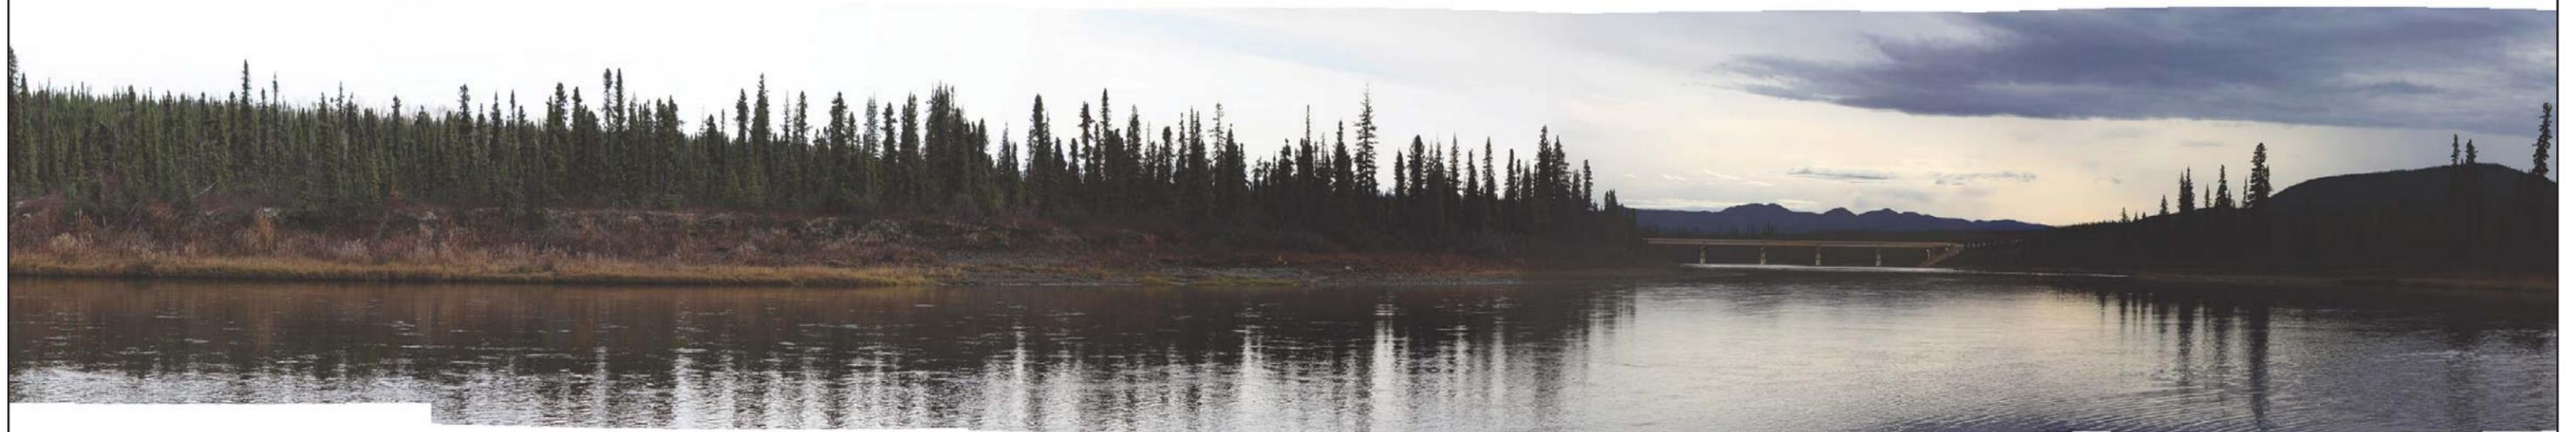
GAAR Visual Impact Analysis KOP 7 - Kobuk RS 1	
	Ambler Mining District Industrial Access Road	
	November 07, 2014	Figure 10

The Kobuk River is one of the most frequented water courses by users in GAAR. This observation point looks south from a sandbar in the river located 0.3 miles upstream of a bridge crossing for the AMDIAR southern route. At 0.3 miles, it is the closest potential campsite upstream of the crossing. No indication of human presence, such as footprints or fire ring was observed at this site. Figure 10 shows the existing view from KOP 7.

The visual simulation depicts a 480' long bridge from 0.3 miles upstream. The bridge would likely come into view for travelers on the Kobuk River at approximately 0.45 miles upstream. Similar to KOP 6, only the bridge is visible from KOP 7 except for a small portion of the road on the west side of the river. The road gradually rises up an embankment from the bridge but is heavily screened by vegetation. Time of day and sunlight again played a part in minimizing the visibility of the bridge in this simulation as it is in a backlit condition here. Again, a photograph of an existing bridge taken from a similar orientation was used in this simulation therefore; we believe that this simulation is an accurate portrayal for the conditions present at the time of the site visit. It can be expected that under different conditions, such as the side of the bridge in direct sunlight, the bridge would be more prominent. Consideration of coloring and texture of the bridge could mitigate the visual impact. Figure 10 shows the view from KOP 7 with the simulated road.

KOP 7 - Kobuk RS 1 Existing - Looking South (South Route)

KOP 7 - Kobuk RS 1 After Construction - Looking South (South Route)

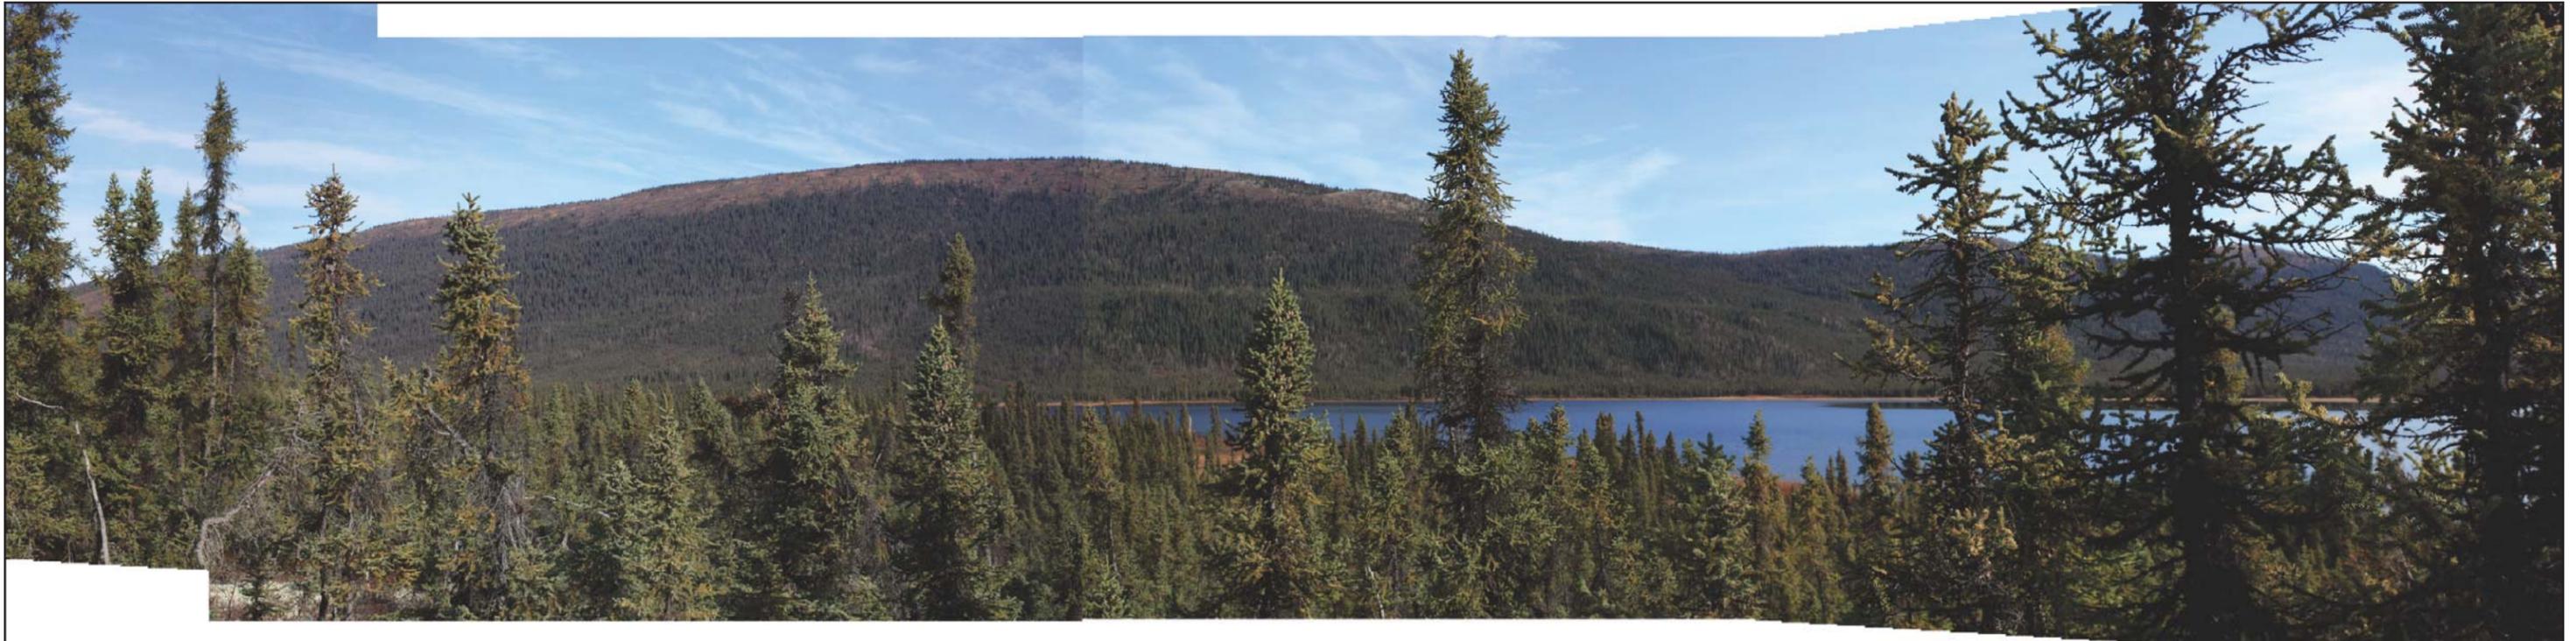
The observation point at Nutuvukti Lake is on a small rise within an open spruce forest which provided a partially obstructed view to the north across the lake. A small cabin is located 0.3 miles from the site and an old survey marker was found nearby. Figure 11 shows the existing view from KOP 8.

From KOP 8 the AMDIAR northern route would likely be visible as it traverses a broad hillside above Nutuvukti Lake. The profile of the road along the traverse averages 18 feet in height. The fill slope created will likely be visible. Sections of mature spruce forest along the slopes will provide substantial screening along portions of the road. Other areas support shorter vegetation and would not be expected to provide as much screening. Not knowing the exact height of the trees, best efforts were made to accurately portray the visual impact of the road and vegetative screening. The simulation also demonstrates a potential color contrast between the road fill slope and the existing forest if the embankment material is of a high albedo.

KOP 8 - Nutuvukti Lake Existing - Looking North (North Route)

KOP 8 - Nutuvukti Lake After Construction - Looking North (North Route)

Re-vegetation of fill slopes with native seed, trees and/or shrubs on topsoil could be used as a mitigation technique to reduce the contrast between the gravel road and the existing forest. Additionally, realigning the road from where it contours along the side of hill in an extended traverse to the toe of the slope and closer to the valley floor would reduce the prominence of the road. Figure 11 shows the view from KOP 8 with the simulated road.
