PRELIMINARY VISUAL IMPACT ANALYSIS

NOVEMBER 2014

**AMBLER MINING DISTRICT INDUSTRIAL ACCESS ROAD
PRELIMINARY VISUAL IMPACT ANALYSIS**

November 2014

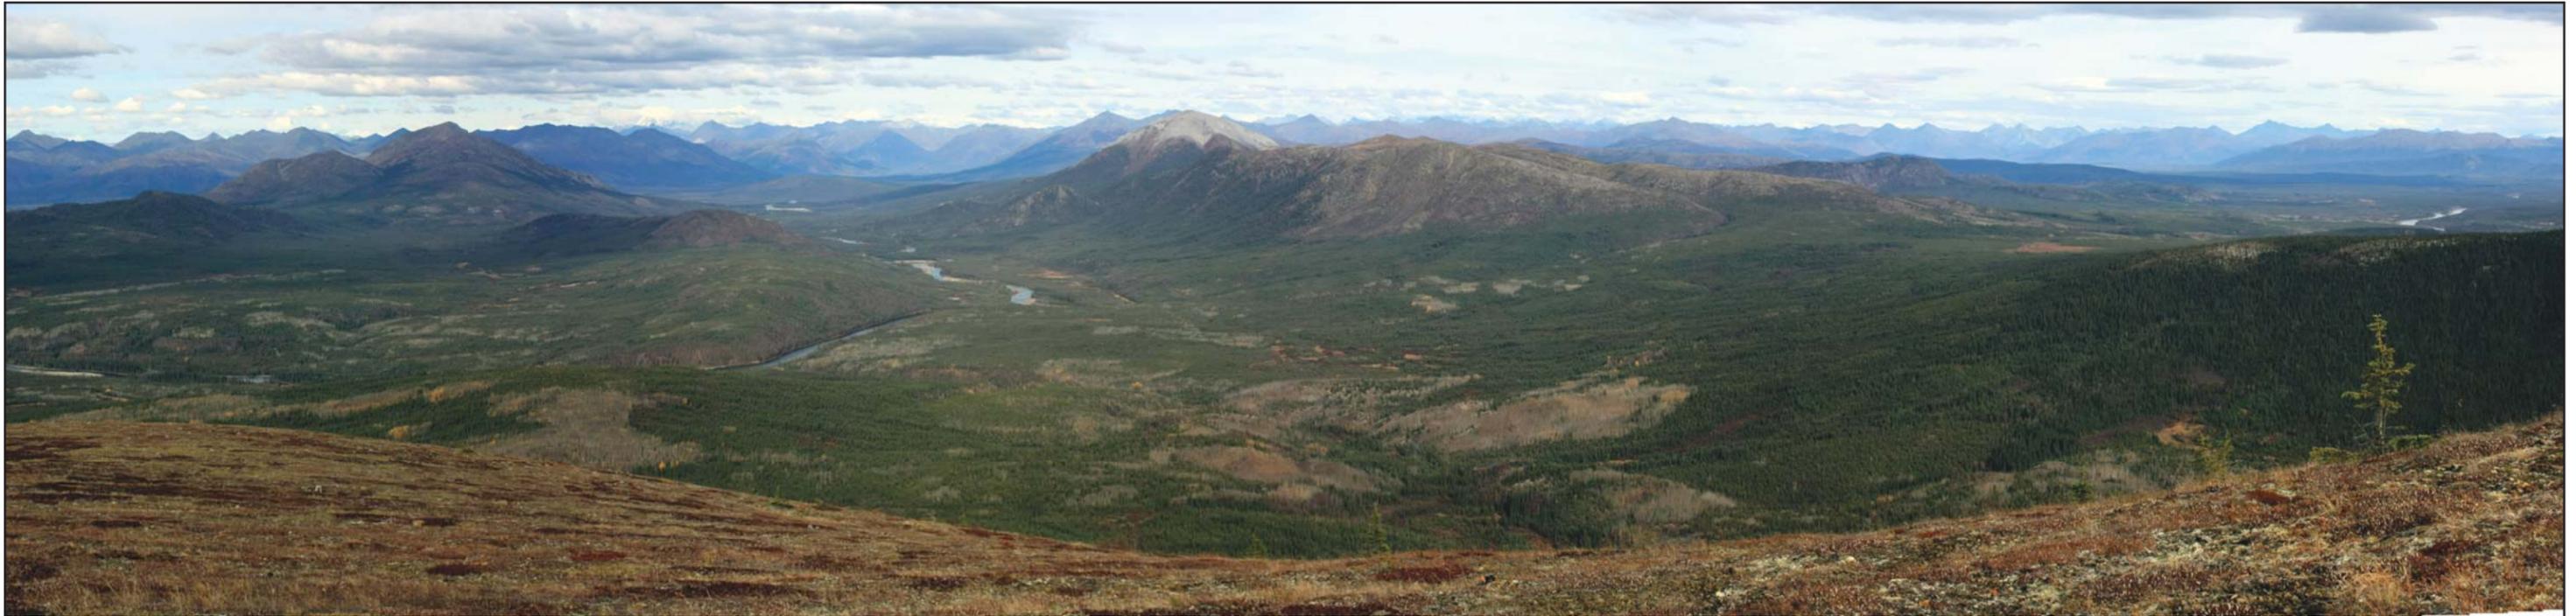
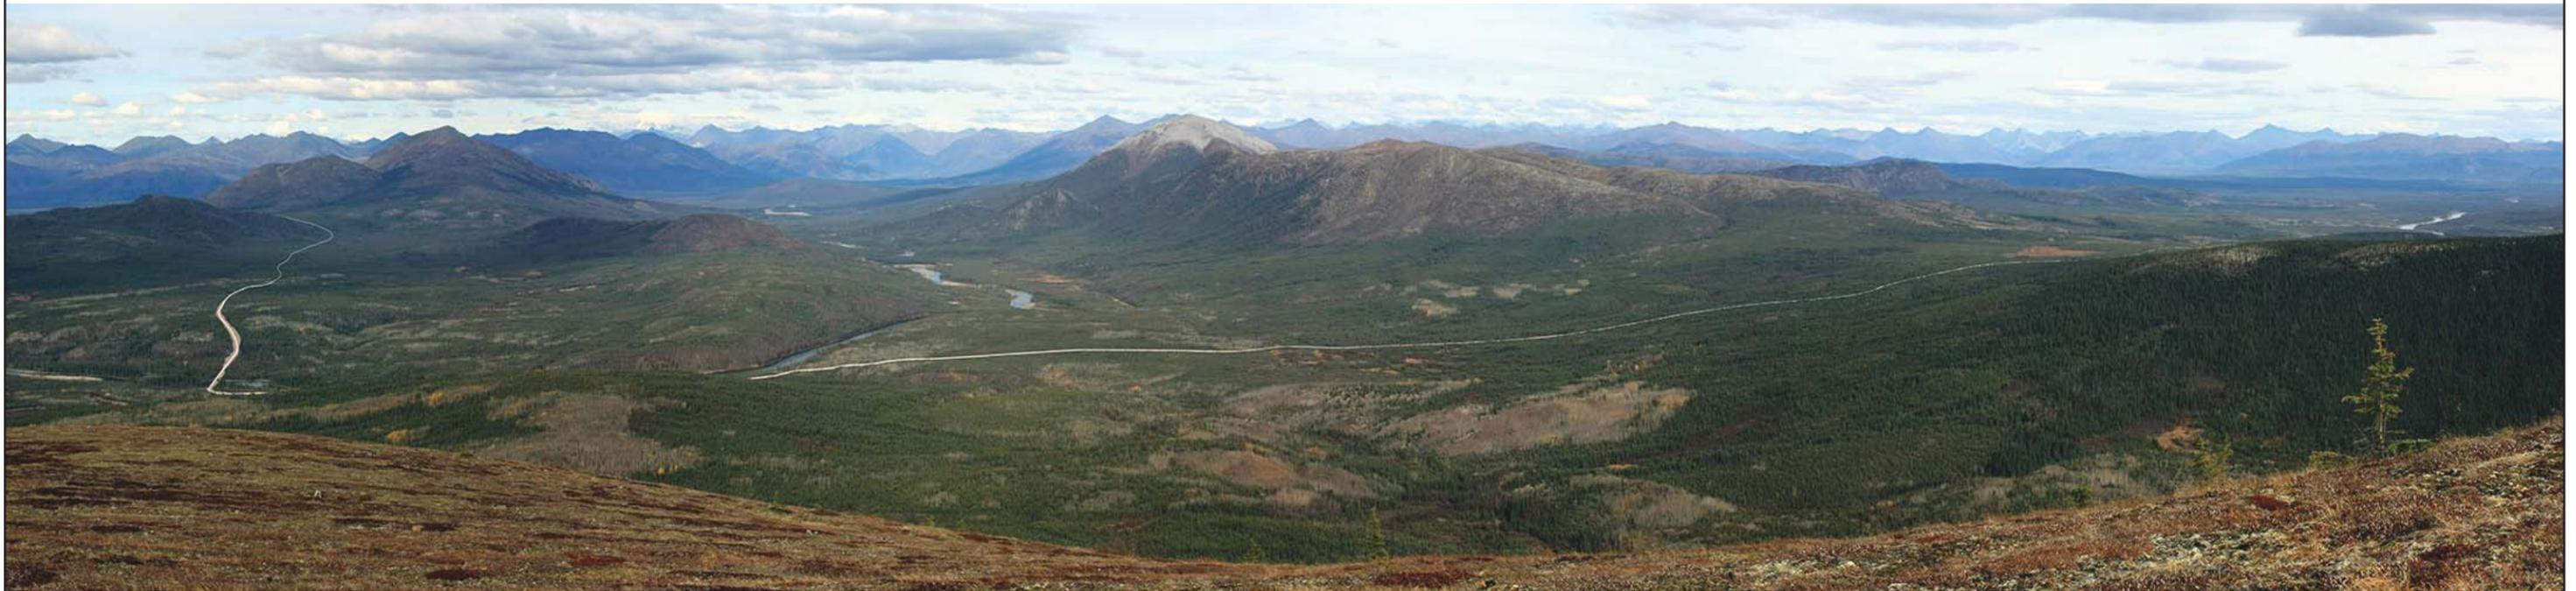
GAAR Visual Impact Analysis KOP 9 - Kobuk RS Ridge 3	
	Ambler Mining District Industrial Access Road	
	November 07, 2014	Figure 12

The scenic quality for this north looking observation point was ranked very high as it has an elevated view over an expansive and scenic panorama. One of the main features at KOP 9 is the view up the Reed River drainage, a U-shaped glacially carved valley. The site could be accessed by foot from the Reed River and KOP 6 which lies 2.2 miles to the north. The Kobuk River is visible 5.1 miles to the east northeast. Figure 12 shows the existing view from KOP 9.

From KOP 9 the visual simulation depicts the southern route of AMDIAR approaching the Reed River from the north, passing through a large double-sided road cut, and bridging the Reed River before making a 90 degree turn to the east where it passes through the landscape in front of the viewpoint. Finally, the road disappears from view behind a hill prior to reaching the Kobuk River. Best efforts were made to accurately convey the effects of vegetative screening where it appeared probable. Figure 12 shows the view from KOP 9 with the simulated road.

KOP 9 - Kobuk RS Ridge 3 Existing - Looking North (South Route)

KOP 9 - Kobuk RS Ridge 3 After Construction - Looking North (South Route)

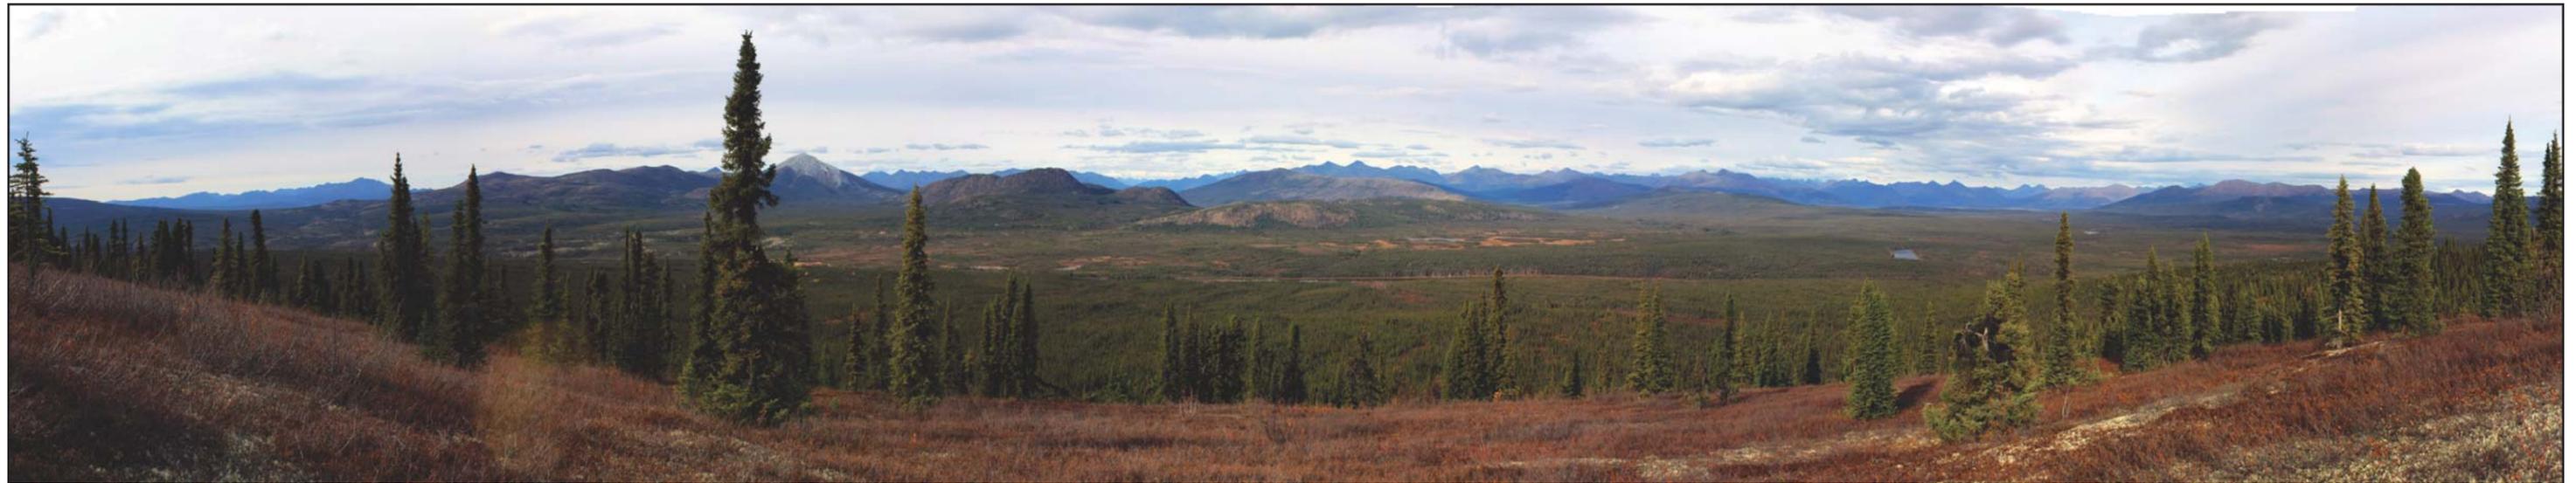
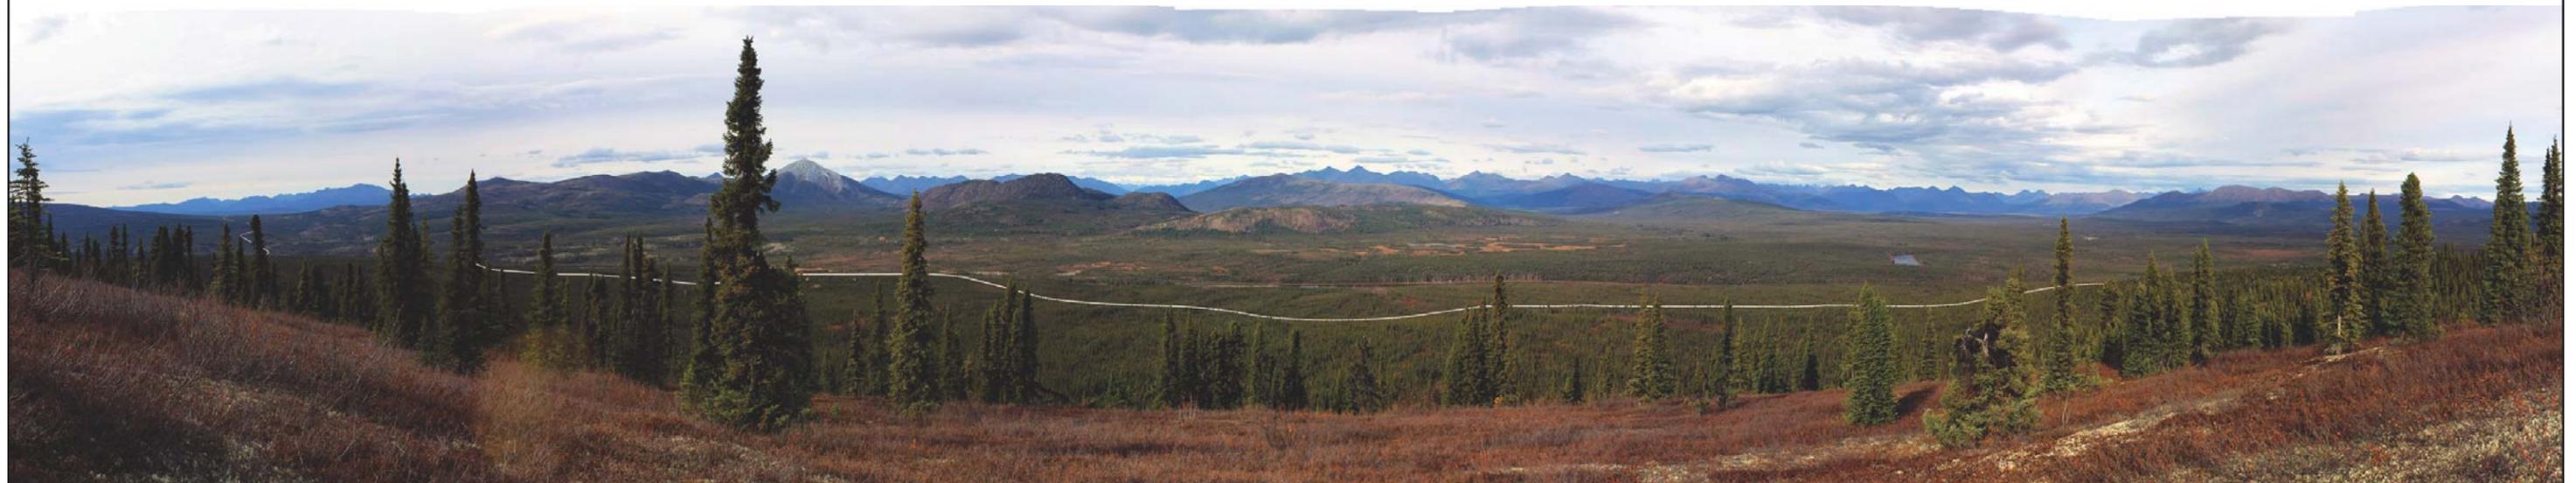
GAAR Visual Impact Analysis KOP 10 - Kobuk RS Ridge 1	
	Ambler Mining District Industrial Access Road	
	November 07, 2014	Figure 13

This observation point lies approximately 6.8 miles northeast of KOP 9 and 1.9 miles east of KOP 7. It is located on a low hill looking north above the Kobuk River with tundra vegetation and sporadic spruce trees 15'-25' in height. Although the river is 1.1 miles away, there are only a few glimpses of the water and the impression of the far riverbank as it crosses the view from east to west. No major lakes or other rivers are visible for KOP 10 Figure 13 shows the existing view from KOP 10.

In the visual simulation the AMDIAR southern route is visible as it cuts through the view from east to west, between the Kobuk River and KOP 10. The road passes within 1 mile of KOP 10, through dense spruce forest. It is probable that the road in the valley would be less visible than depicted due to the density of the vegetation on the valley floor. A bridge crossing of the Kobuk would be located two miles to the west, but it is not visible from KOP 10 as terrain blocks the line of sight to the river crossing. Figure 13 shows the view from KOP 9 with the simulated road.

KOP 10 - Kobuk RS Ridge 1 Existing - Looking North (South Route)

KOP 10 - Kobuk RS Ridge 1 After Construction - Looking North (South Route)
